# Remedy Oak Golf Club, Dorset

## Clubhouse

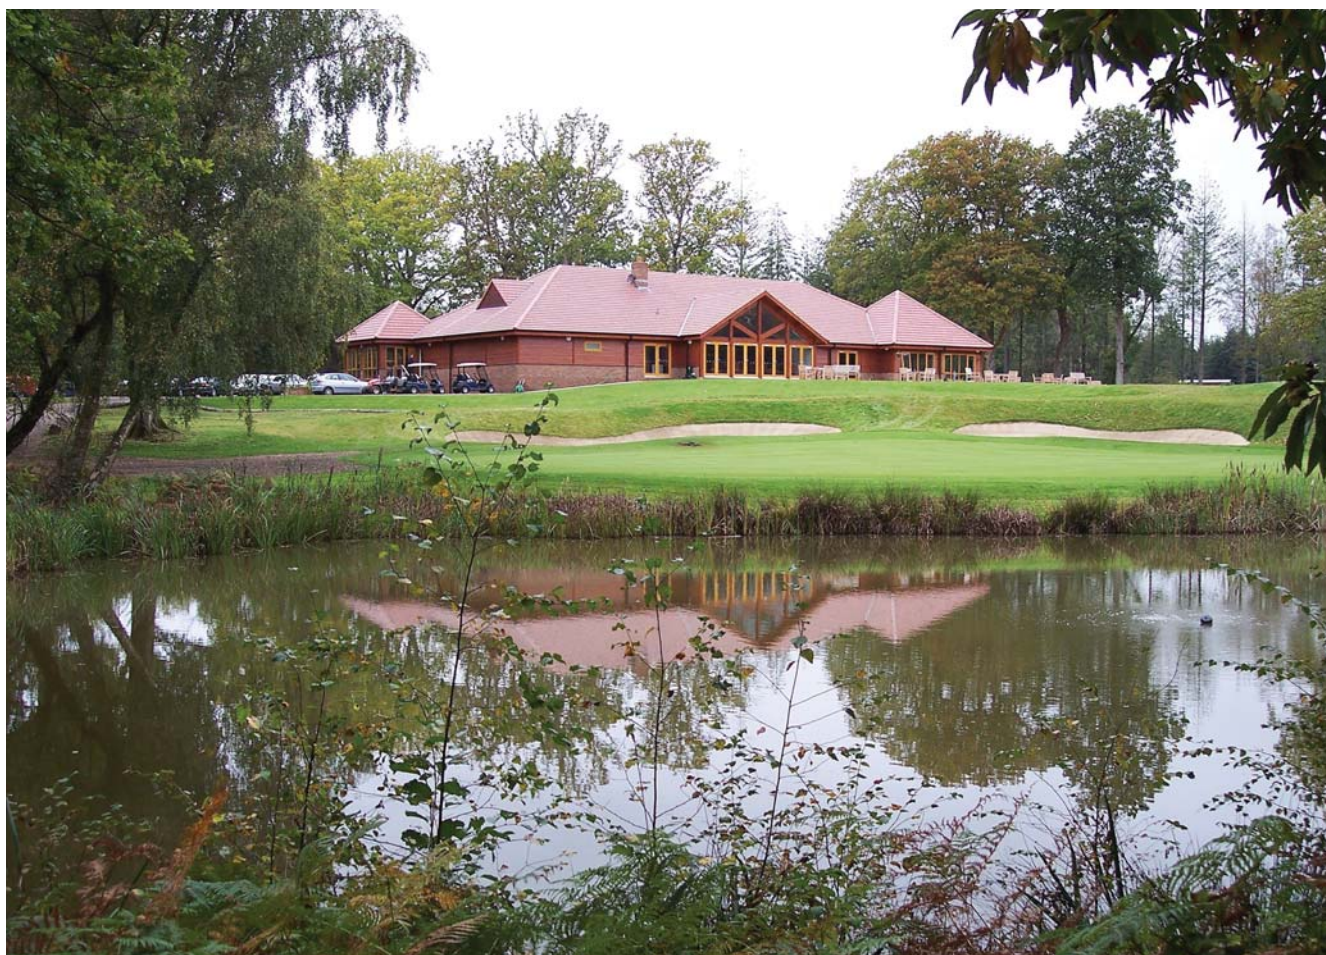
As the client was looking for natural yet low-maintenance external finishes, PDB specified a brick plinth and cladding using horizontal Siberian larch panels.

Siberian larch was chosen because it is hard, durable and requires little maintenance. Over time it tends to fade to an attractive silver grey colour.
